CHERRYSTONE NO. 1

PITTSYLVANIA COUNTY, VIRGINIA

VA. NO. 14302

PHASE I INSPECTION REPORT

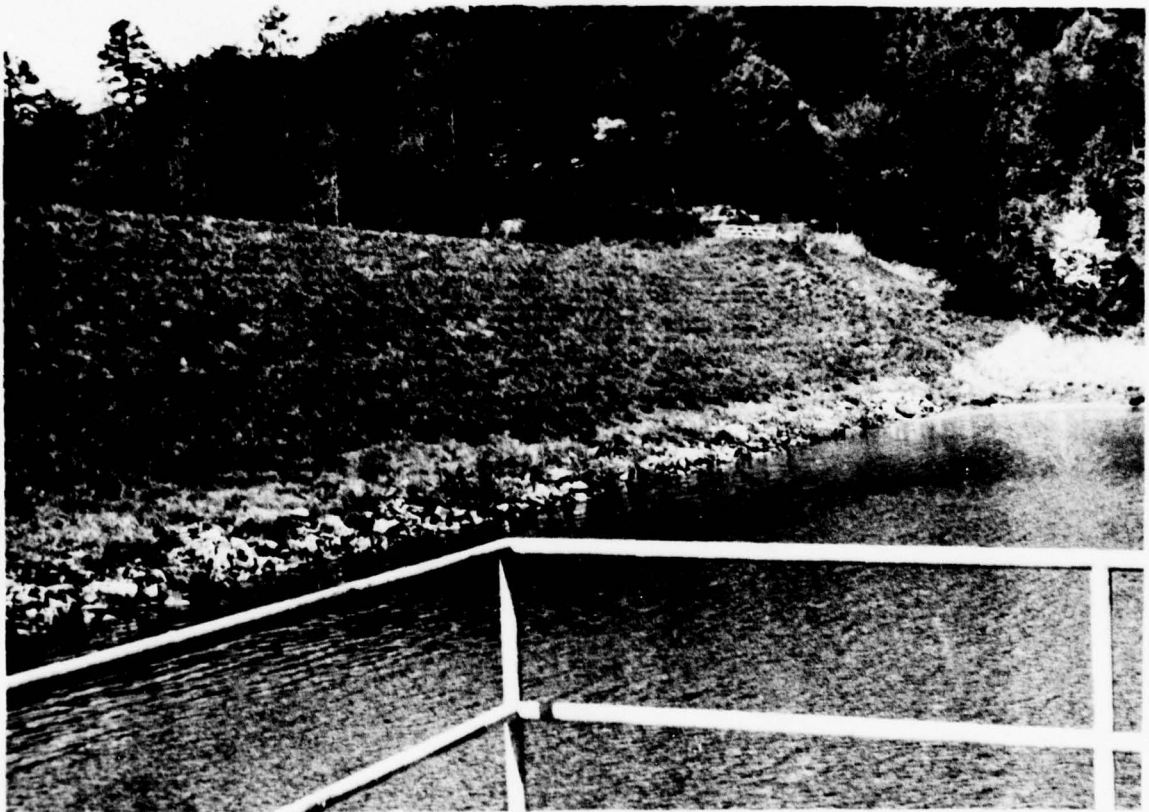
UPSTREAM FACE OF EARTHEN IMPOUNDMENT
Photo #1

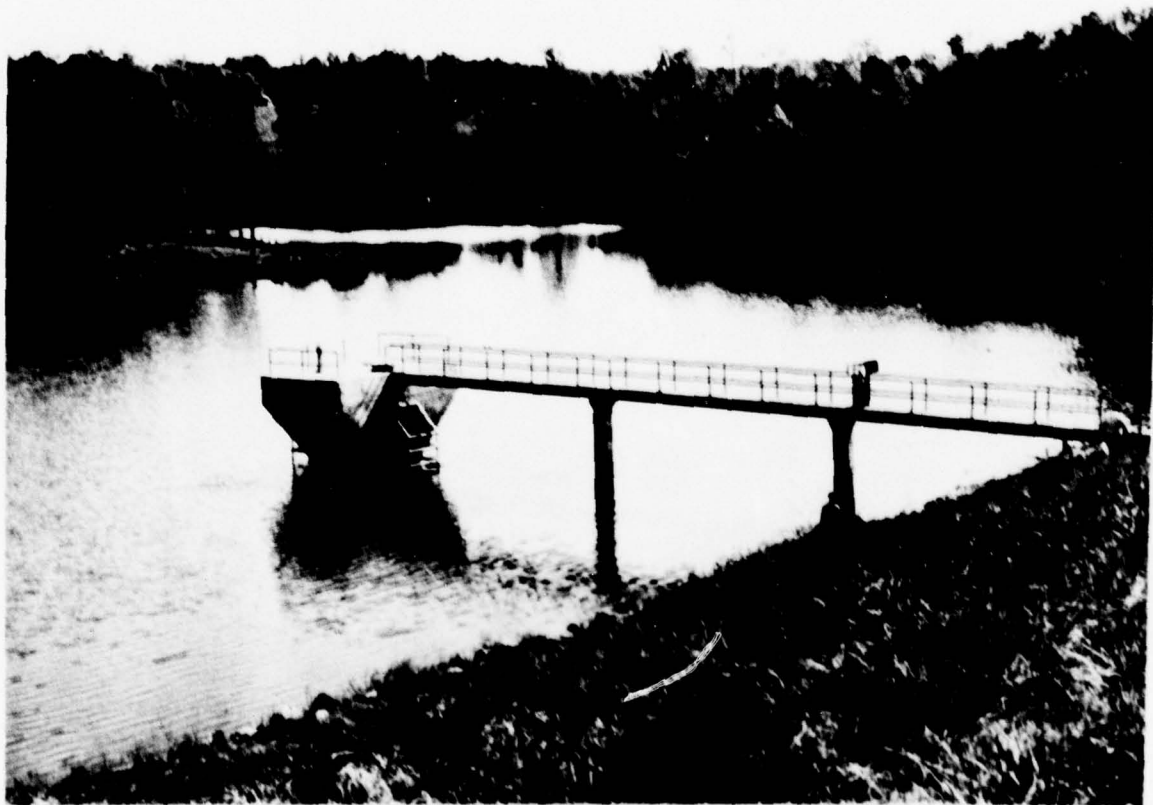
The intake is in good conditions. No spalling or cracking was observed. A small amount of debris was noted in the trash rack. The manhole cover is missing from the structure. The gates have not been operated since 1972. The energy dissipator was in good condition and functioning properly.

INTAKE STRUCTURE AND CATWALK
Photo #2

7.2.4 Replace manhole on principal spillway inlet structure.

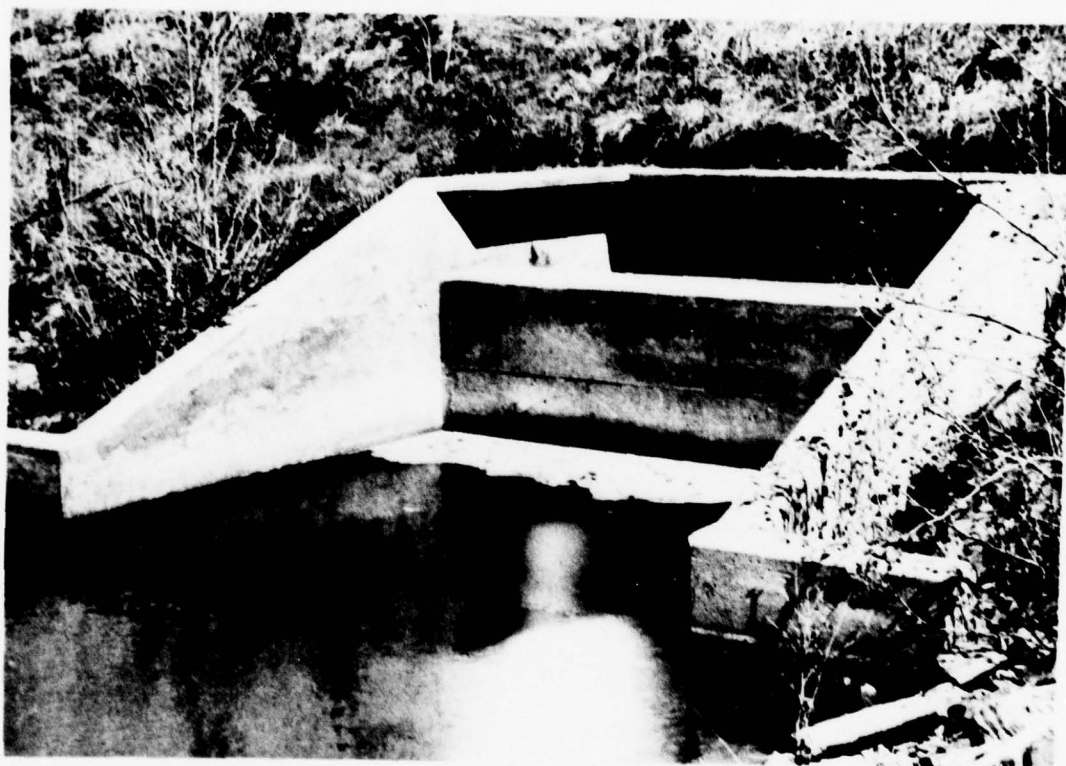
Photo #4

OUTLET ENERGY DISSIPATOR
Note: Outlet Channel Flow

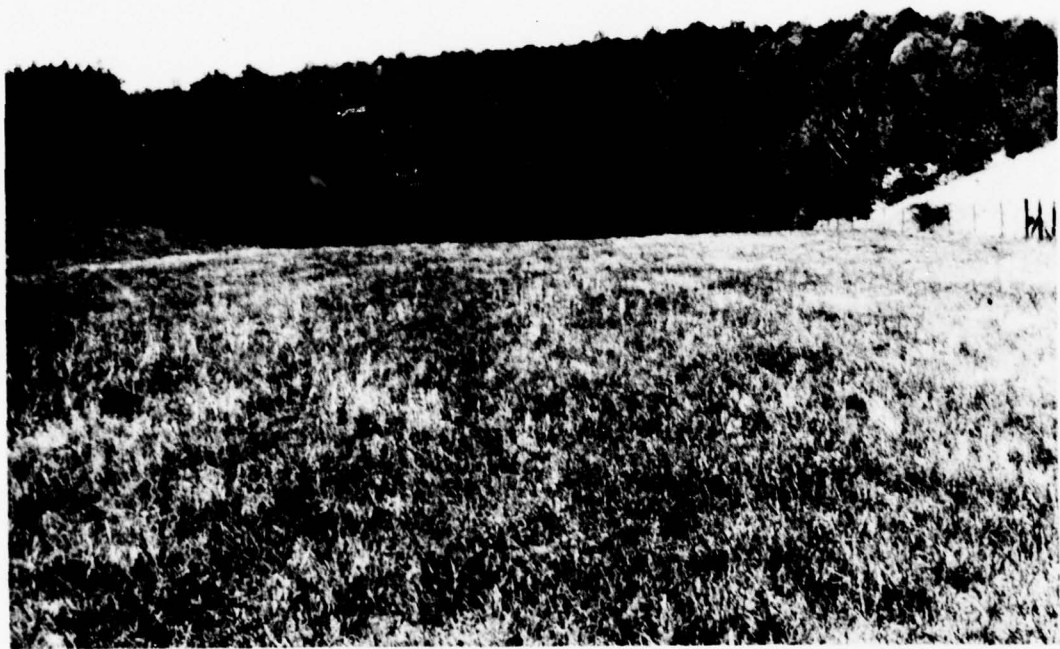
Photo #5

VIEW EMERGENCY SPILLWAY

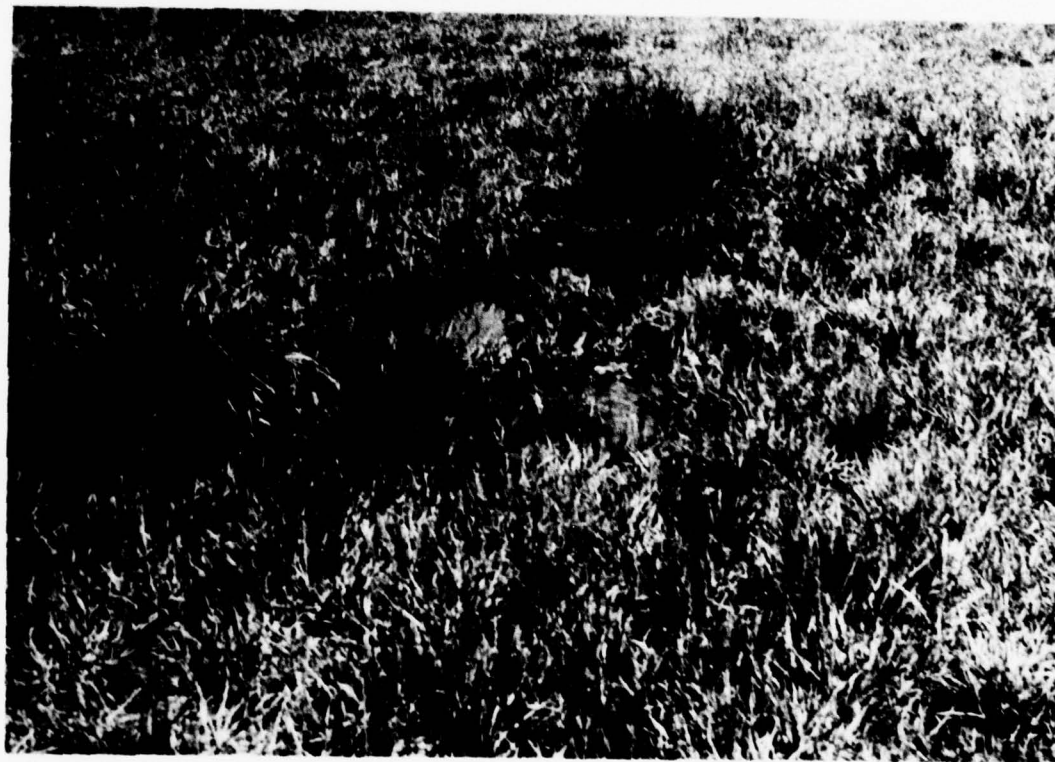
Photo #6

The moisture observed below the downstream toe of the embankment is not considered to be related to seepage through the dam.

WET SPOT NOTED DOWNSTREAM OF LEFT ABUTMENT
